SUPPLEMENTAL DATA

ASCE Journal of Geotechnical and Geoenvironmental Engineering

Application of MLR Procedure for Prediction of Liquefaction-Induced Lateral Spread Displacement

San Fernando Juvenile Hall Lateral Spread

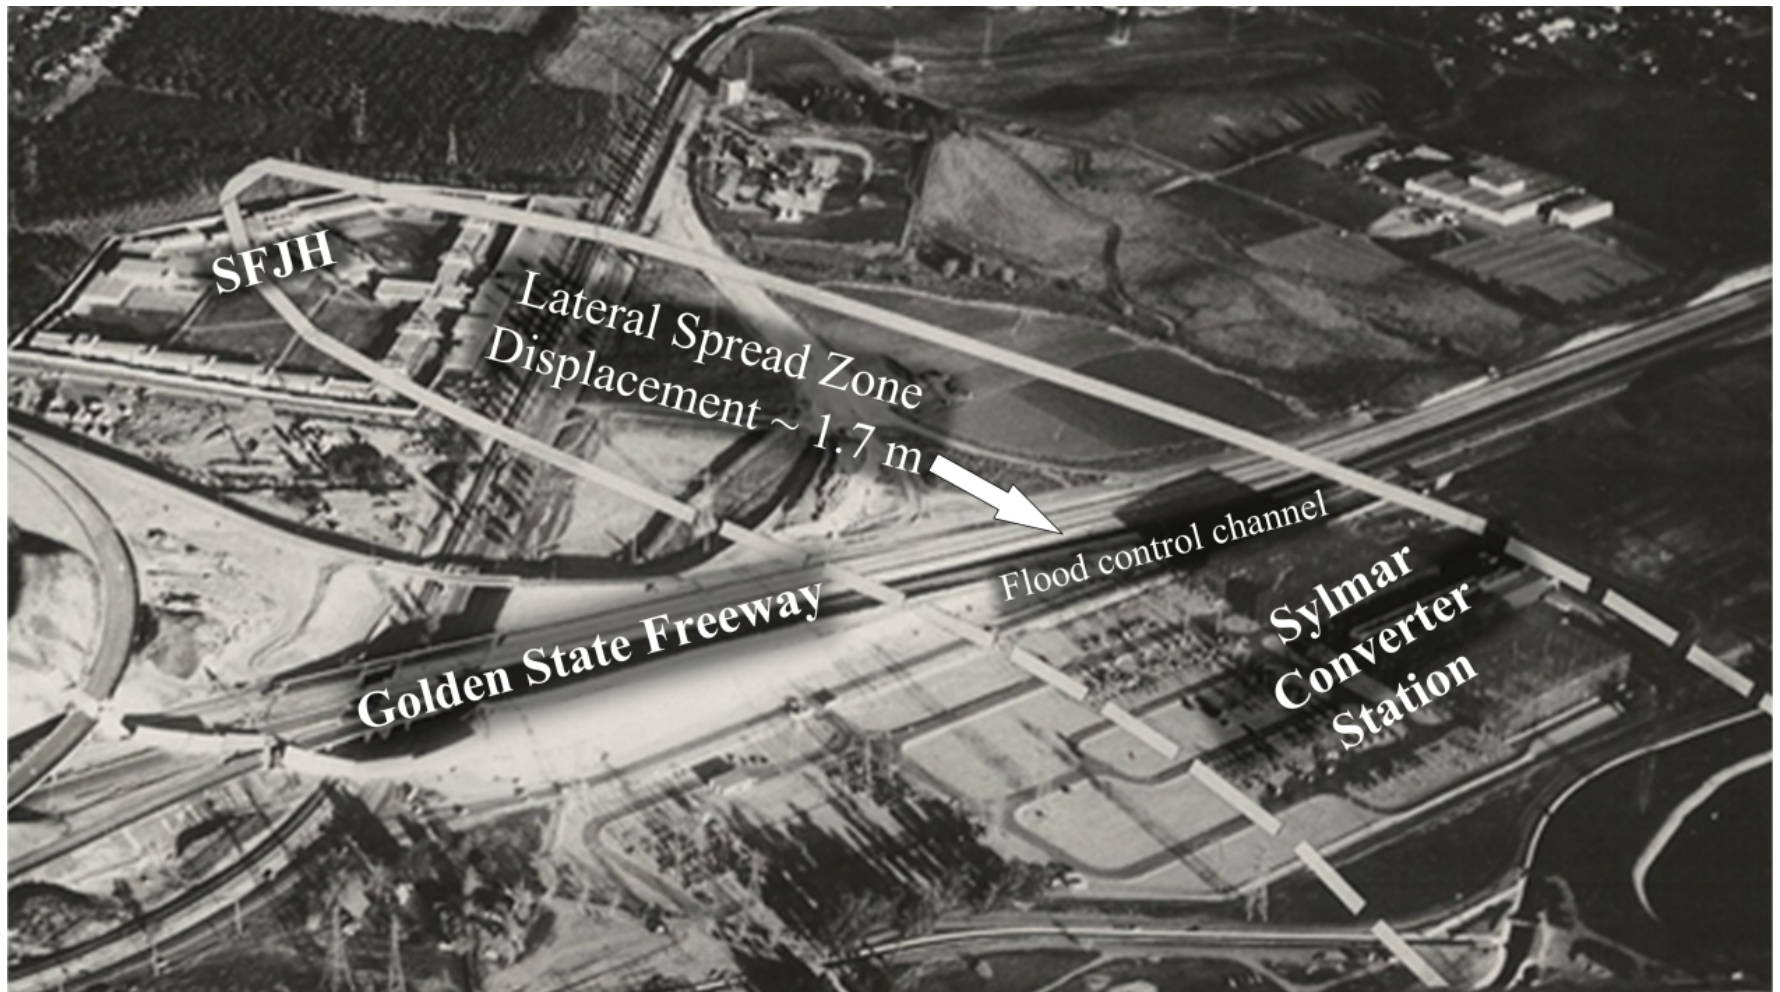
Fig. S1. Aerial photograph of San Fernando Juvenile Hall (SFJH) with annotated boundaries of SFSH lateral spread generated by the 1971 San Fernando earthquake ($M = 6.6$) (USGS photo)

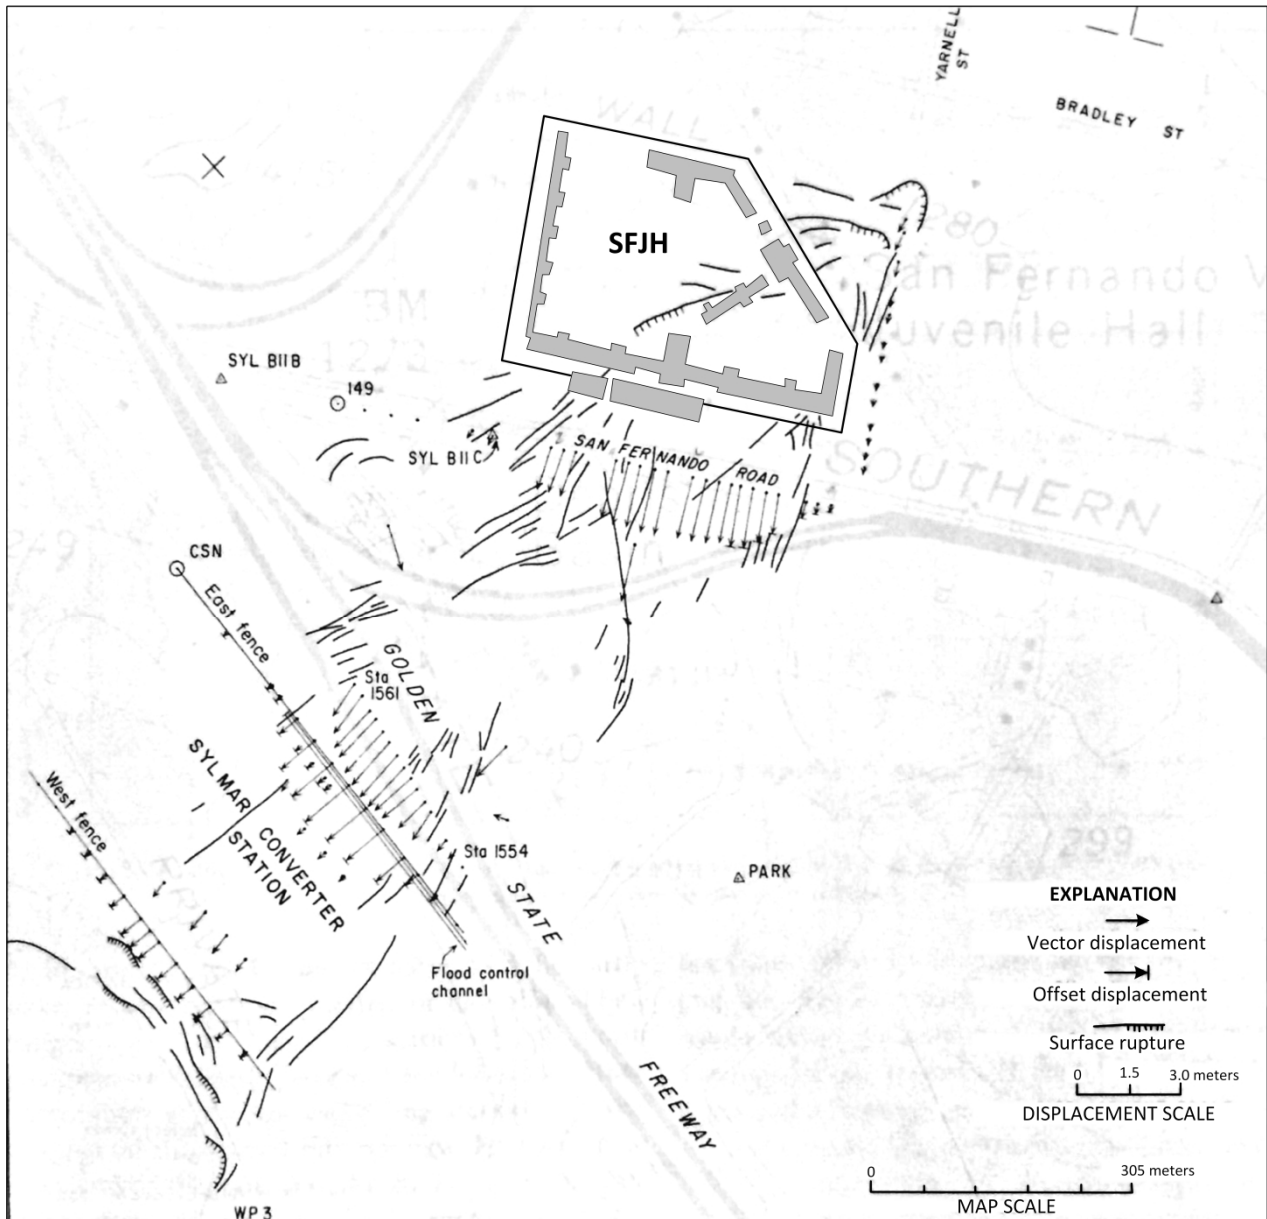
Fig. S2. Map of SFJH area with measured lateral spread displacements and mapped ground fissures (Youd 1973)

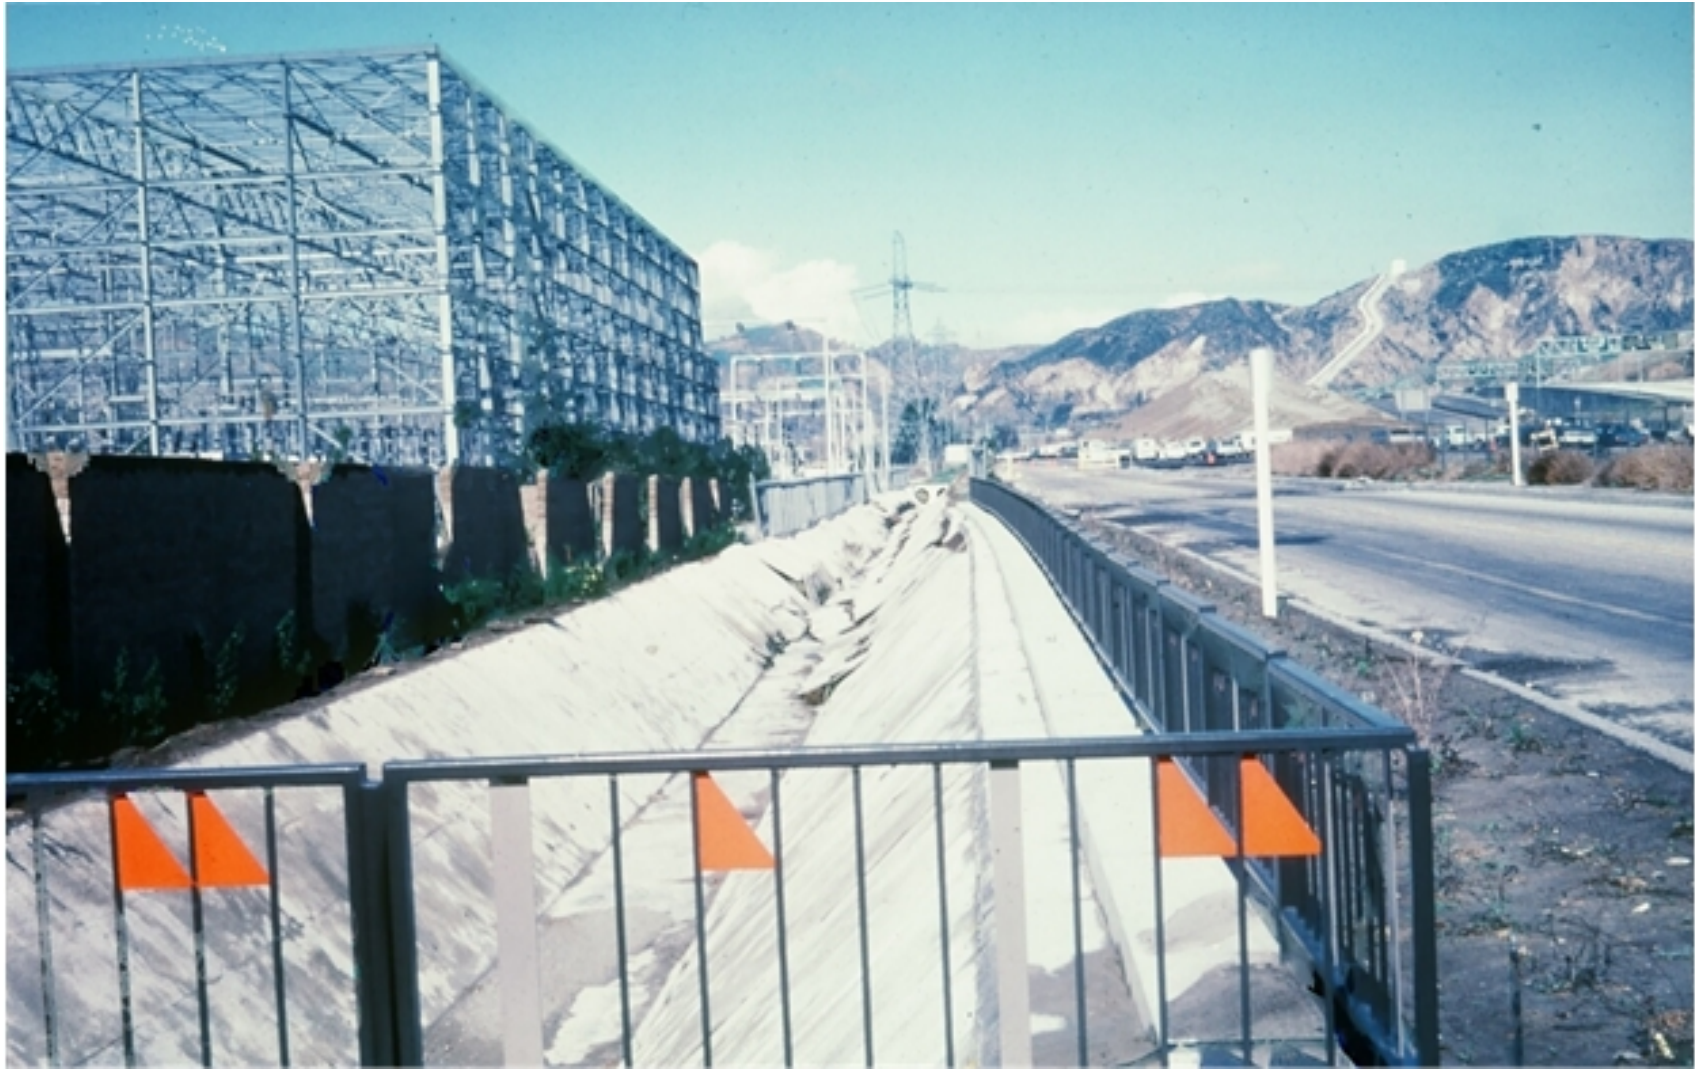
Fig. S3. Flood control channel compressed by SFJH lateral spread; channel acted as a partial toe for the spread (T.L. Youd photo)

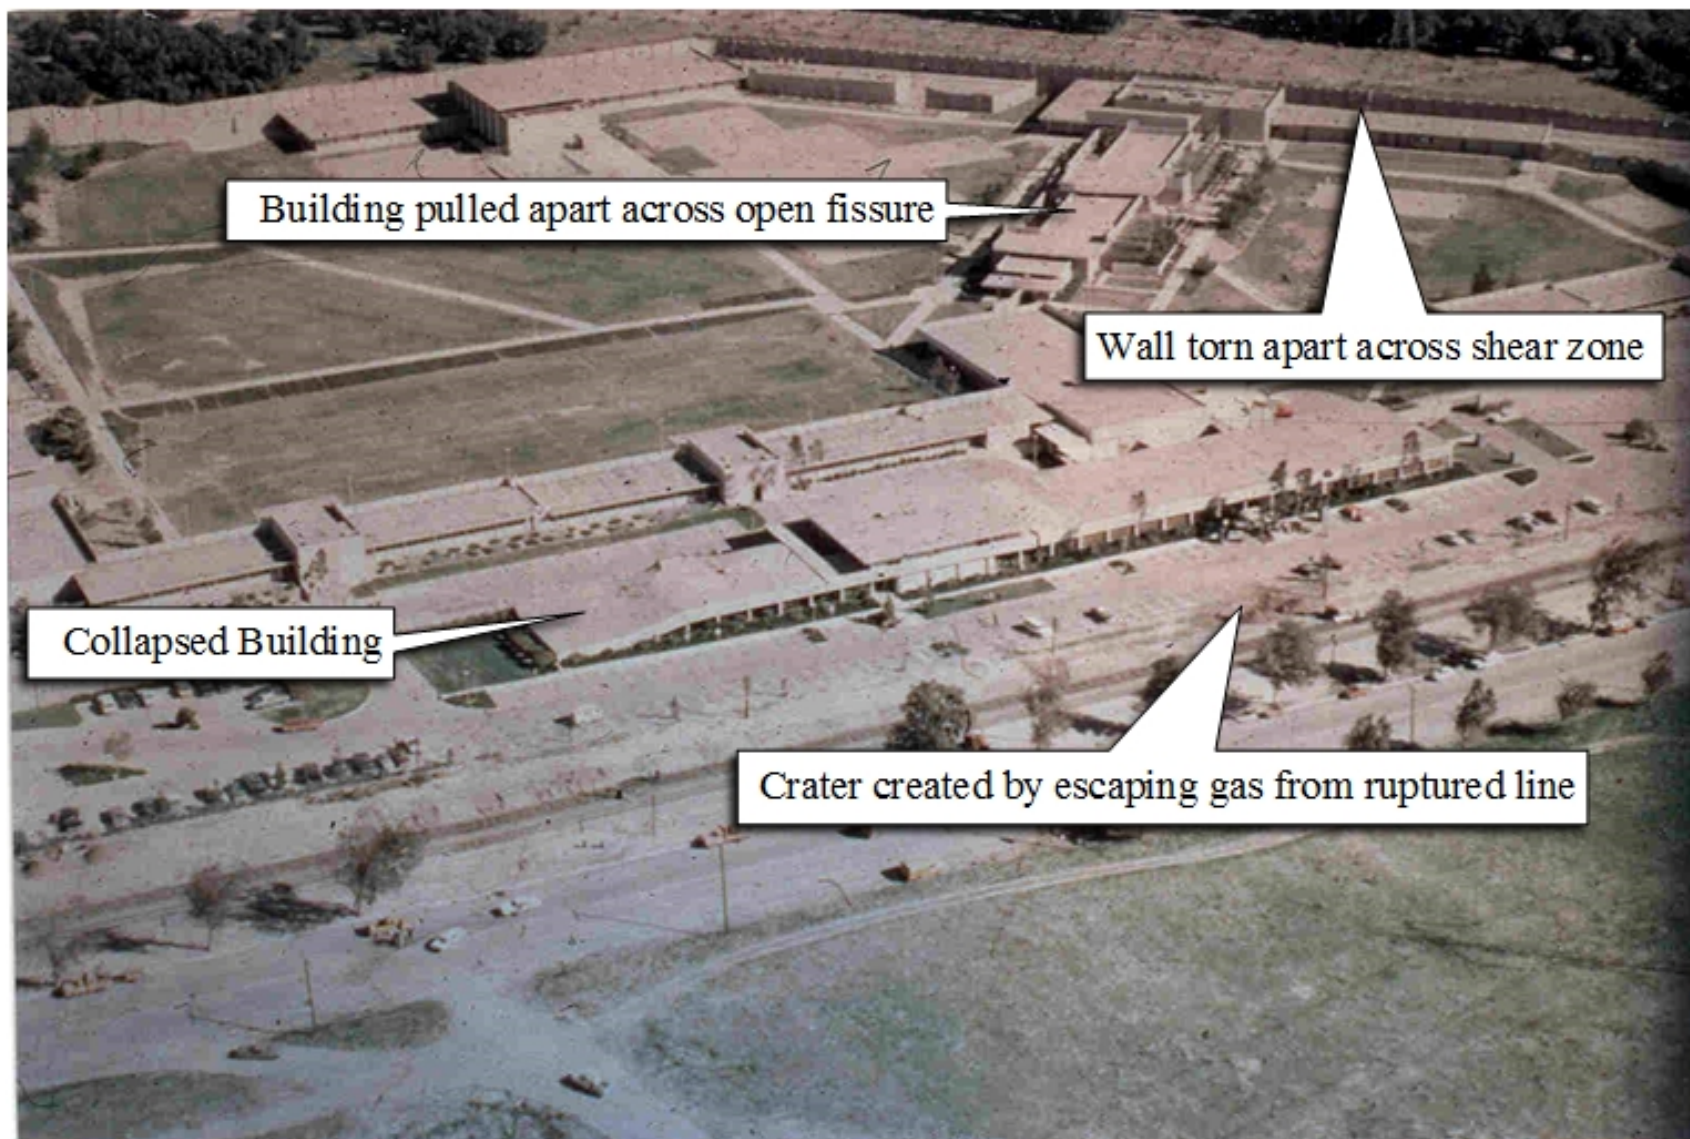
Figure S4 is an aerial photo of SFJH with annotation marking localities of significant damage. Figure S5 is a photo of a collapsed building that housed a court facility. Fissures and distorted ground in front of the collapse continued beneath the building and were caused by differential lateral displacement near the western margin of the lateral spread. In this instance, the right end of the building displaced about 0.9 m (toward the camera) relative to the left end which remained nearly in place. The shear deformation fractured the concrete floor slab and distorted building columns, causing the structure to collapse. Because the earthquake occurred at 6:00 am, that building was unoccupied and no deaths or injuries occurred. No deaths and only a few minor injuries occurred within SFJH.

Fig. S4. Aerial photograph of SFJH with annotations noting localities of specific damage (USGS photo)

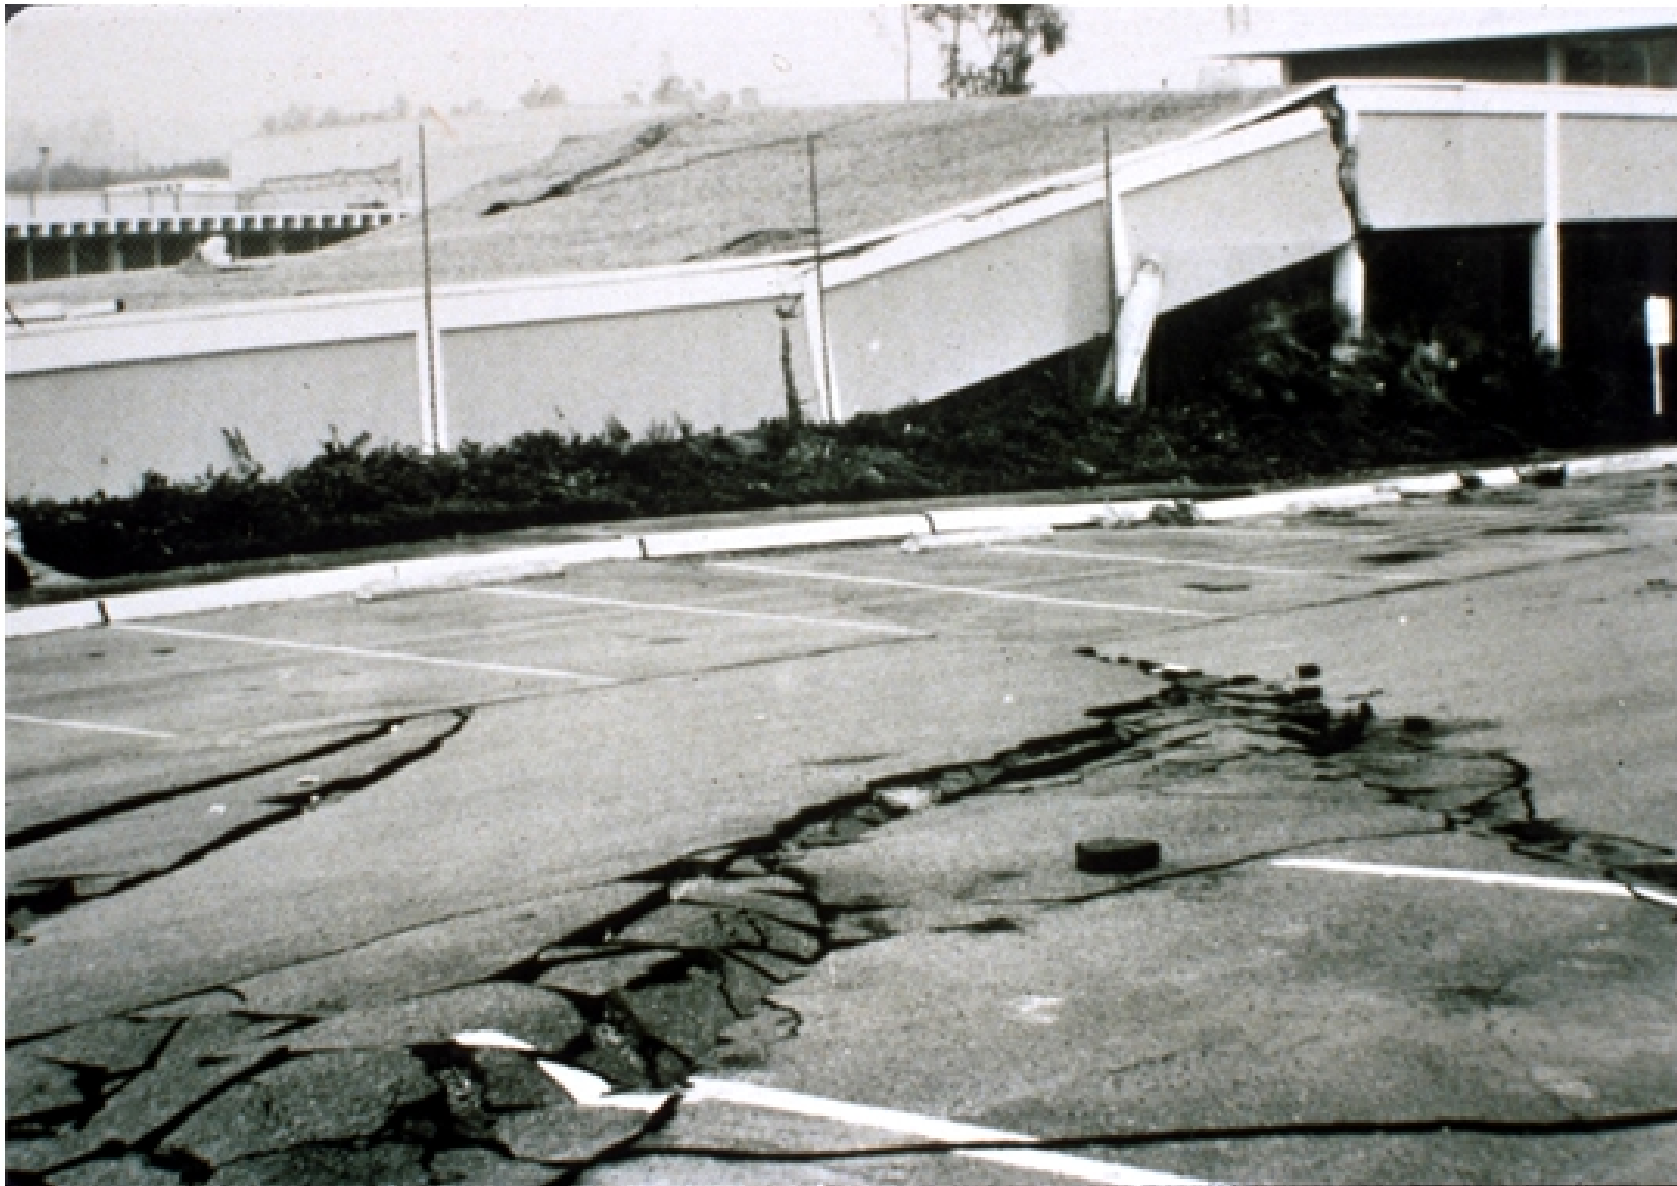
Fig. S5. Collapsed court building at SFJH; collapse caused by differential shear displacement beneath the building; right end of the building displaced about 0.9 m toward the camera relative to the left end which remained nearly in place (T.L. Youd photo)

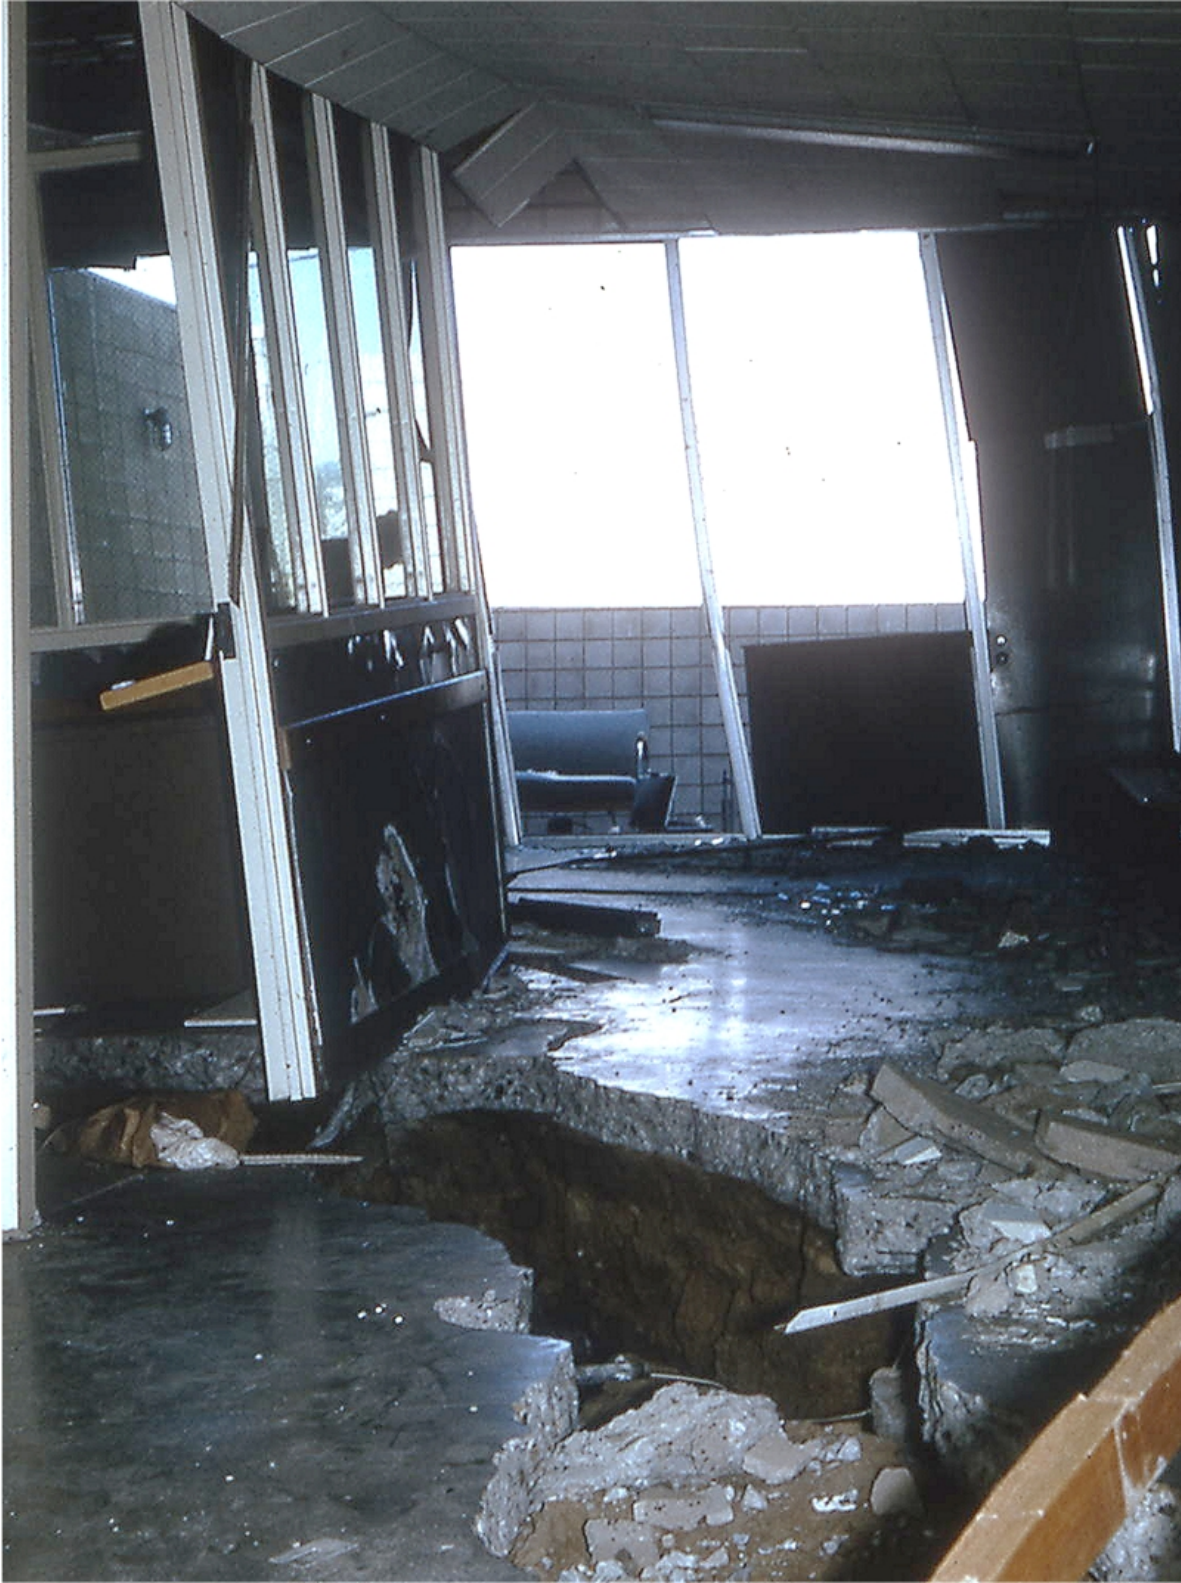
Figure S6 is a view of the interior of a building, in the central part of SFJH, pulled apart by about 0.5 m of extensional ground displacement. No rebar is exposed in the fractured concrete indicating the slab was unreinforced. The building was sufficiently flexible, however to absorb the floor and building disturbance without collapse. A worker seated at a nearby desk as the floor fractured was mightily frightened but uninjured.

Fig. S6. Segment of floor slab pulled apart by extensional ground displacement beneath a SFJH building due to lateral spread movement (T.L. Youd photo)

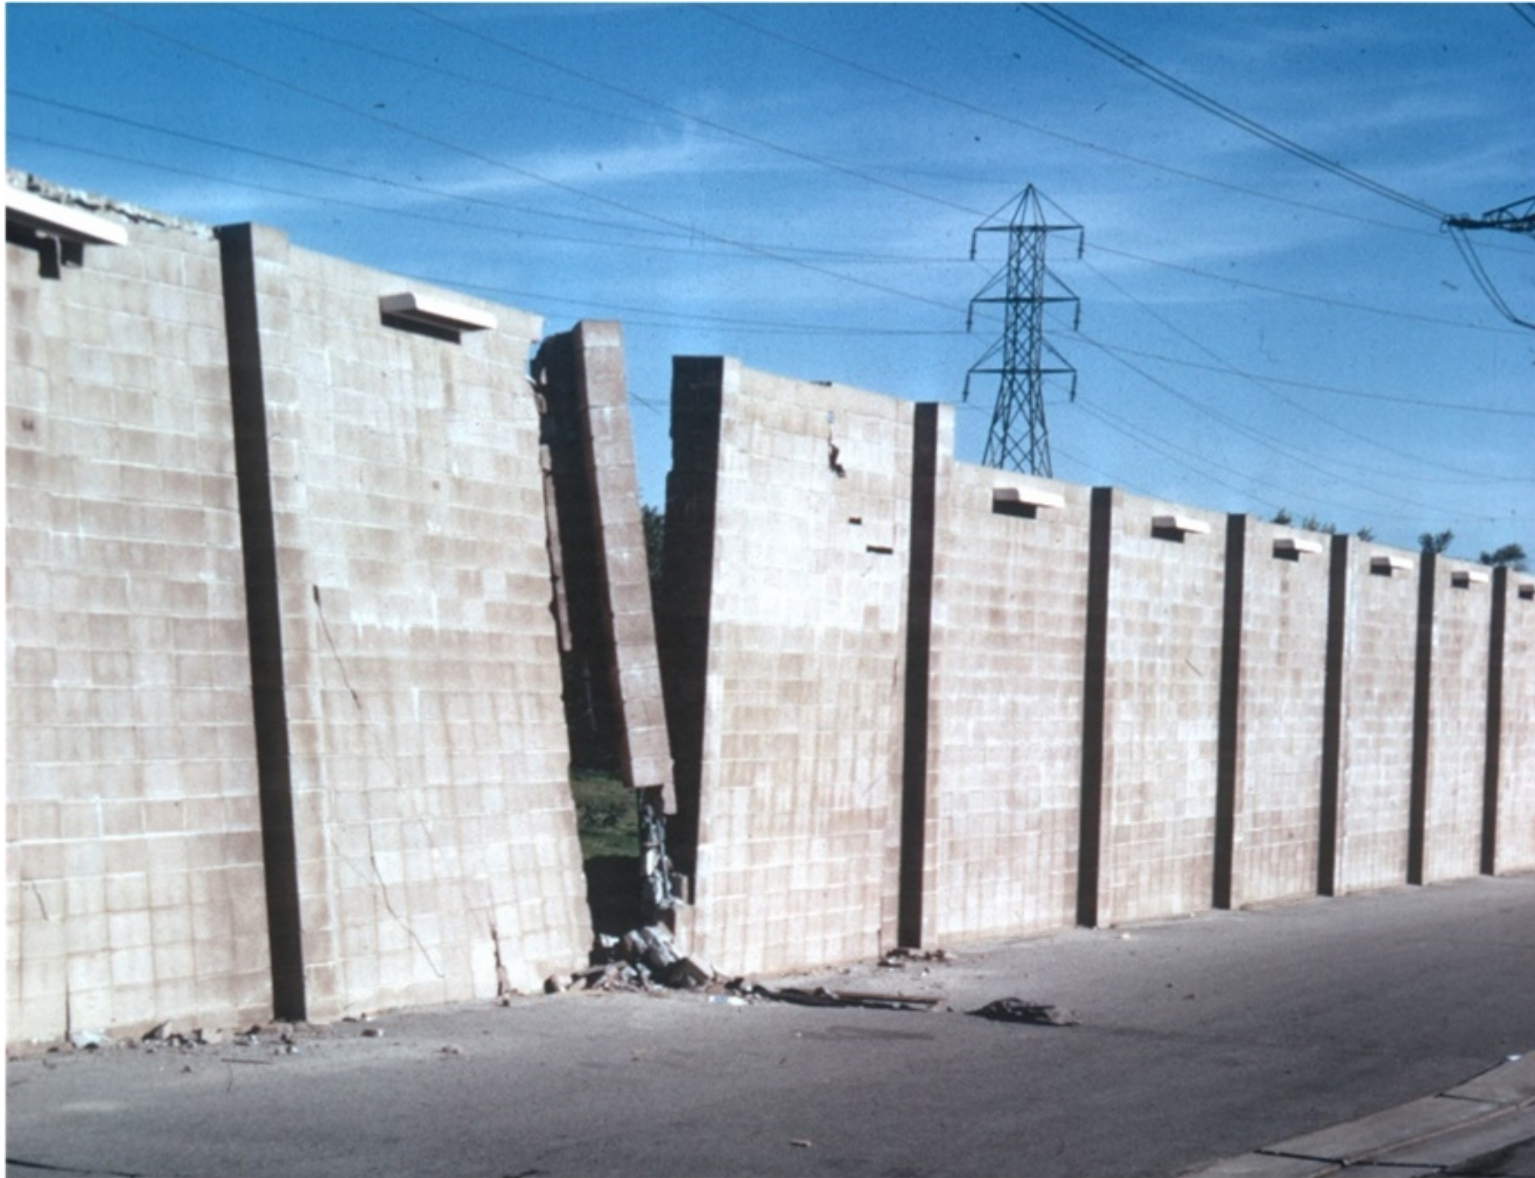
Figure S7 shows a segment of wall surrounding SFJH that was pulled apart due to extensional displacement near the head of the spread. About 50 inmates from the facility escaped through the wall opening shortly after the earthquake, requiring security officers to round up the escaped juveniles.

Fig. S7. Wall at JFSH pulled apart by lateral spread movement; about 50 juvenile inmates escaped through the fractured wall immediately after the earthquake (T.L. Youd photo)

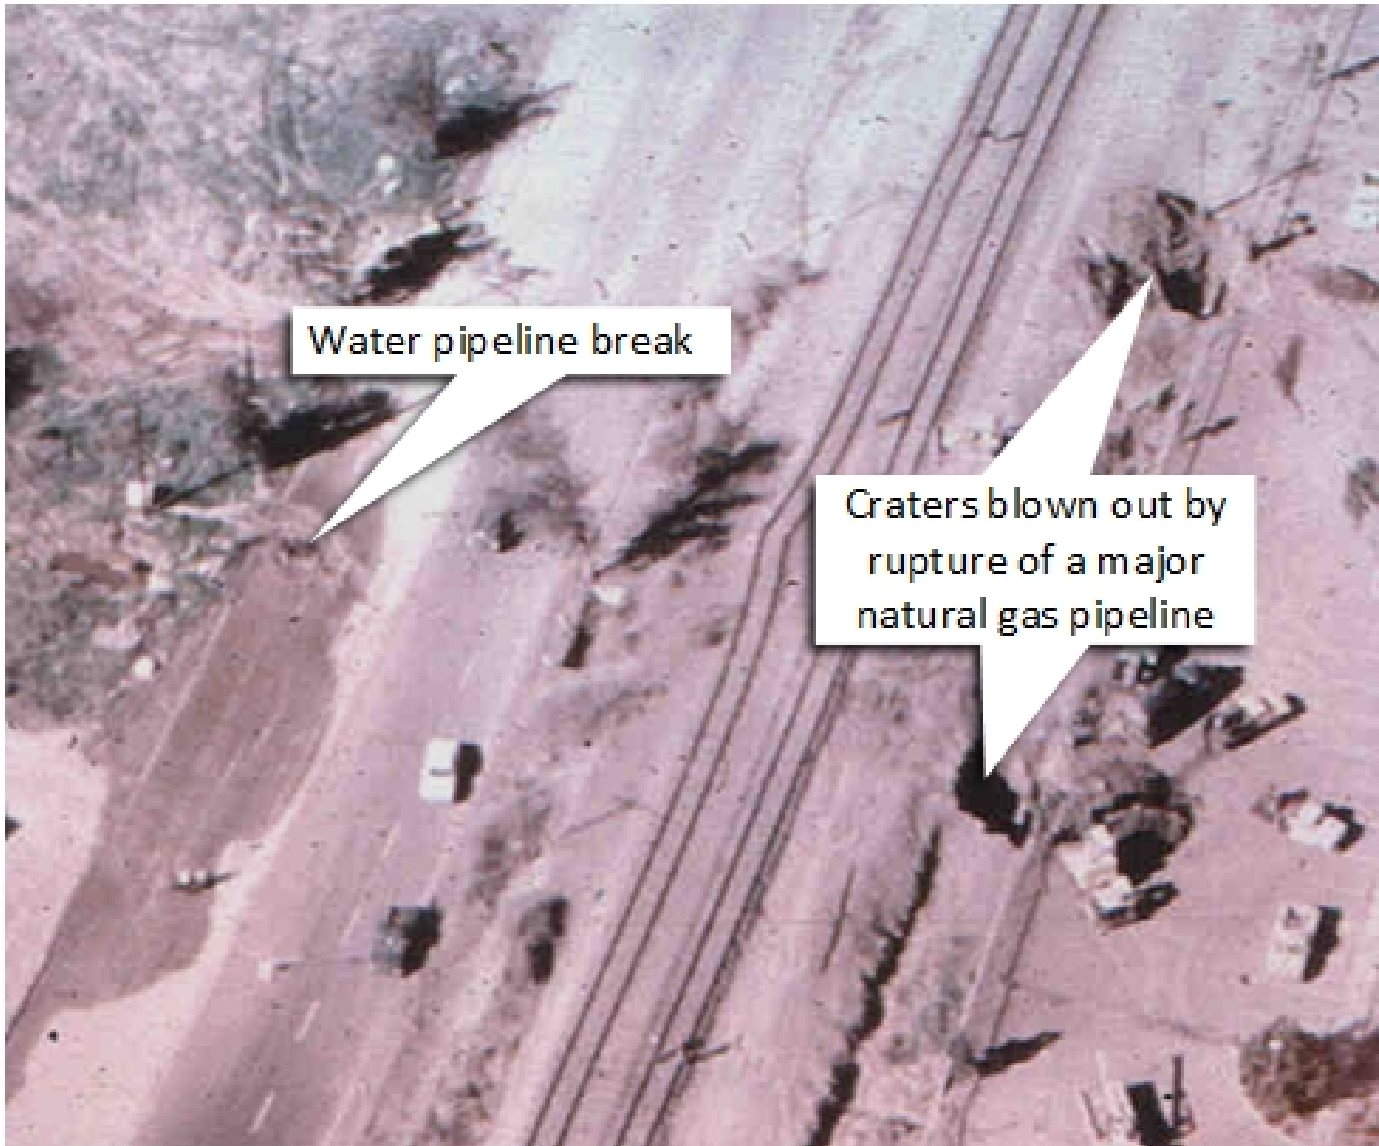
Figure S8 is an aerial view of damage in front of SFJH where the lateral spread displacement ruptured a trunk pipeline transporting natural gas into the San Fernando Valley. The pipeline ruptured at two adjacent localities, where escaping gas blew out craters in the soil above the pipe. Fortunately, the gas did not ignite so damage was limited to ruptured pipe, loss of gas, and unwanted craters in a parking area.

Fig. S8. Aerial photograph of localities of pipeline damage in front of SFJH (T.L. Youd photo)
