# Volumetric Pothole Detection from UAV-Based Imagery

**Abstract:** Road networks are essential elements of a community's infrastructure and need regular inspection. Present practice requires traffic interruptions and safety risks for inspectors. The road detection system based on vehicle-mounted lasers is also quite mature, offering advantages such as high-precision defect detection, high automation, and fast detection speed. However, it does have drawbacks such as high equipment procurement and maintenance costs, limited flexibility, and insufficient coverage range. Therefore, this paper proposes a low-cost unmanned aerial vehicle (UAV)-based alternative using imagery for automatic road pavement inspection focusing on pothole detection and classification. A slicing-based method, entitled the Pavement Pothole Detection Algorithm, is applied to the imagery after it is converted into a three-dimensional point cloud. When compared with manually extracted results, the proposed UAV-structure-from-motion (SfM) method and the associated algorithm achieved 0.01 m level accuracy for pothole depth detection and maximum errors of 0.0053 m<sup>3</sup> in volume evaluation for cases studies o

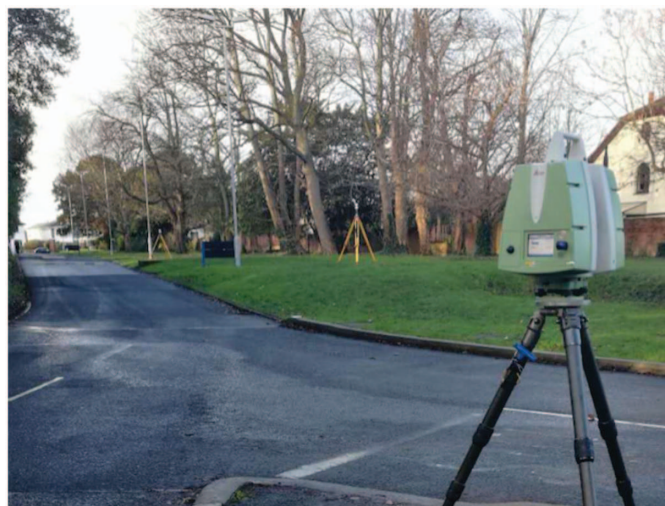
**Fig. 9.** (Color) Leica P20 Scan Station at the data collection site.

To estimate the accuracy of the proposed UAV-SfM data capturing method and related damage-extraction algorithm, TLS data were collected for benchmarking. These data were collected with a Leica P20 Scan Station (Wetzlar, Germany) and postprocessed with Leica's proprietary software Cyclone (V9.1). Potholes were manually extracted from the TLS data as a reference set to compare the performance of the algorithm on both the TLS data set and UAV-SfM data set.

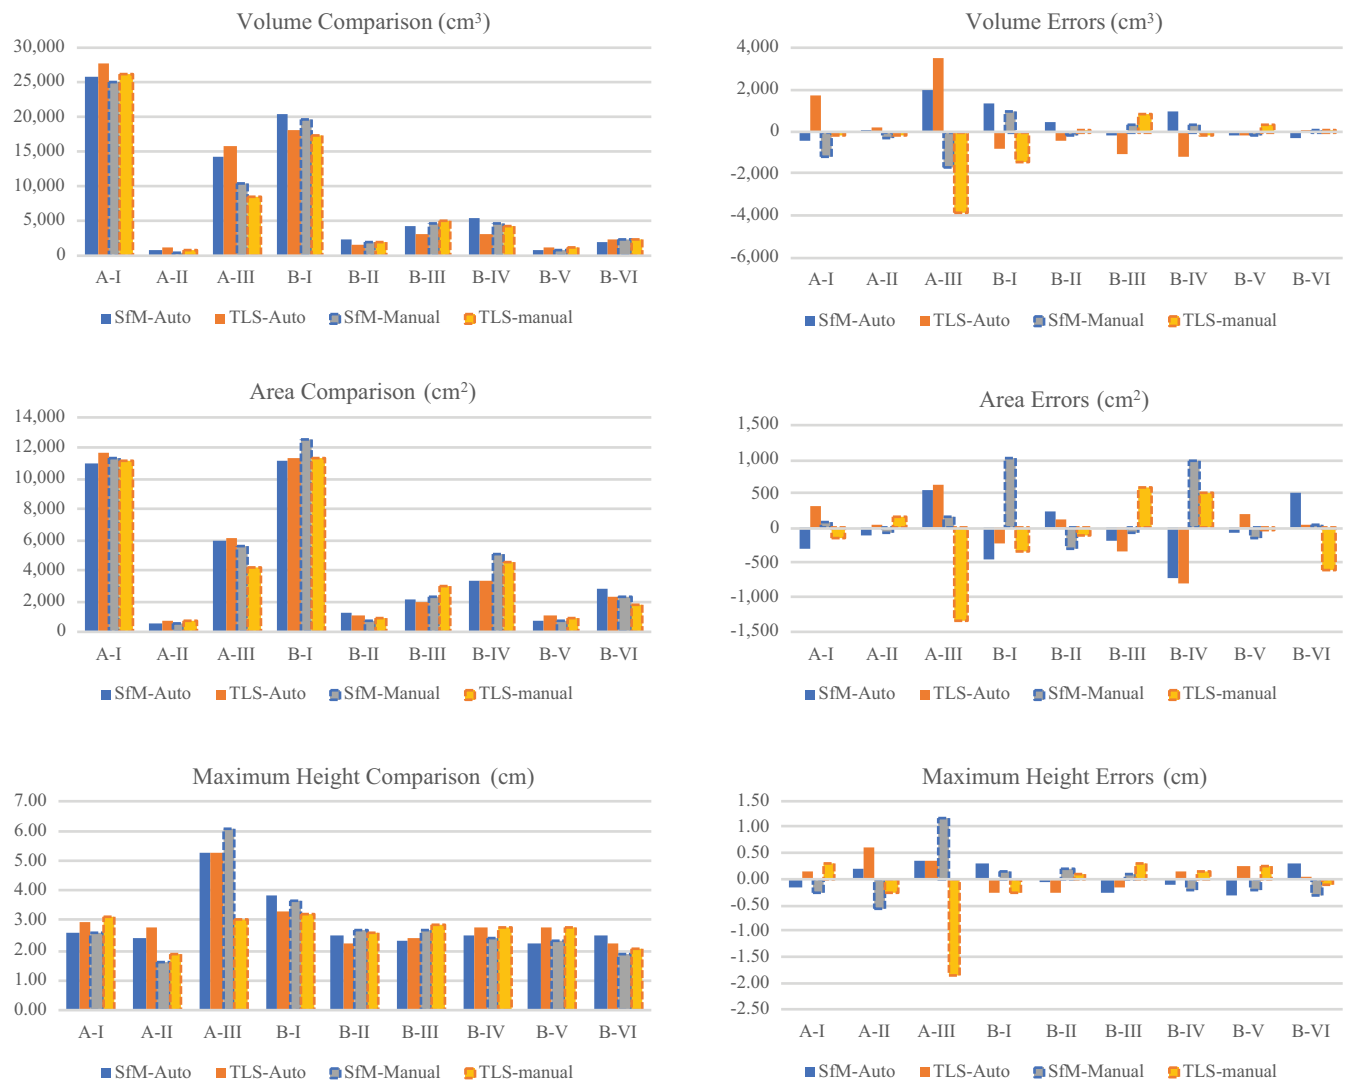
Fig. 13. (Color) Error analysis.

Automatic pothole extraction was applied in both the SfM and TLS point clouds. The manual extraction results of each data set are also presented (Tables 1–6 and Fig. 13). By comparing each result with the average result, the maximum discrepancy in the two data sets was found to occur in Pothole A-III in the UCD road study. A possible reason is that previous repairs posed a challenge for the curve fitting because the final road surface was neither flat nor sloped in a consistent manner. Specifically, Fig. 14 shows the three repaired patches (marked with A, B, and C) causing a different and uneven
